DEFECT INSPECTION REPORT
CLIENT'S ADDRESS /
PROJECT NAME

SAMPLE REPORT

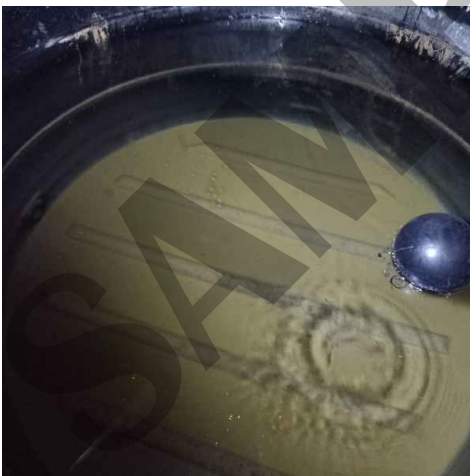
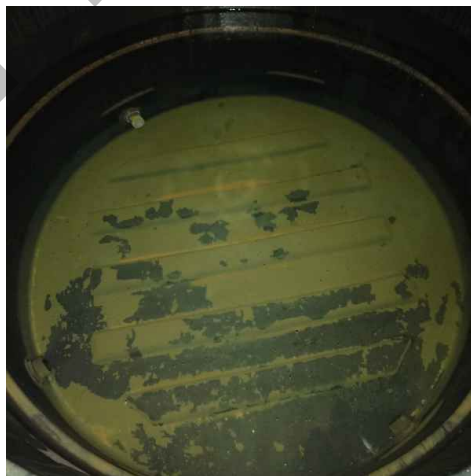
3.7.1 Fixtures

WATER TANK CONDITION

Water Tank found to be in poor condition at the time of inspection. Recommend a qualified contractor to clean the water tank.

- Accumulated sediment in the tank

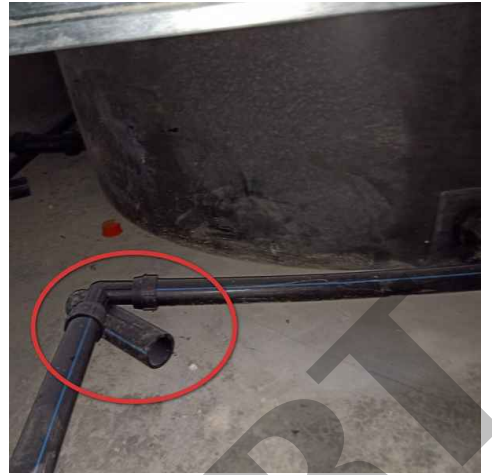
3.8.1 M&E Fittings

Defect Item**IMPROPER INSTALLATION - PIPING SUPPORT**

Improper installation of the piping support observed at the time of inspection. Recommend a qualified plumber to evaluate and remedy.

- Missing piping support

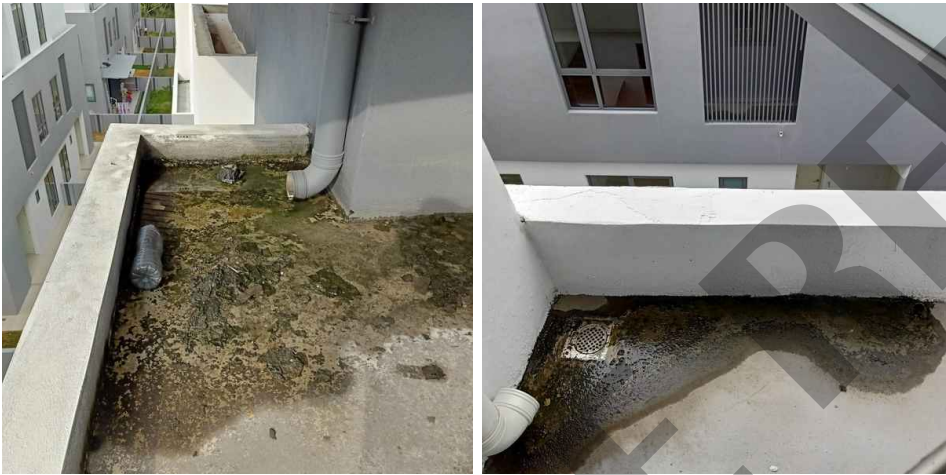
4.2.1 Floor

ALIGNMENT AND EVENNESS

Poor gradient was observed to be at a/c ledge area that causing water ponding and possible water leakage spot. Recommend a qualified contractor to evaluate and rectify the issue.

- Poor gradient
- Water ponding

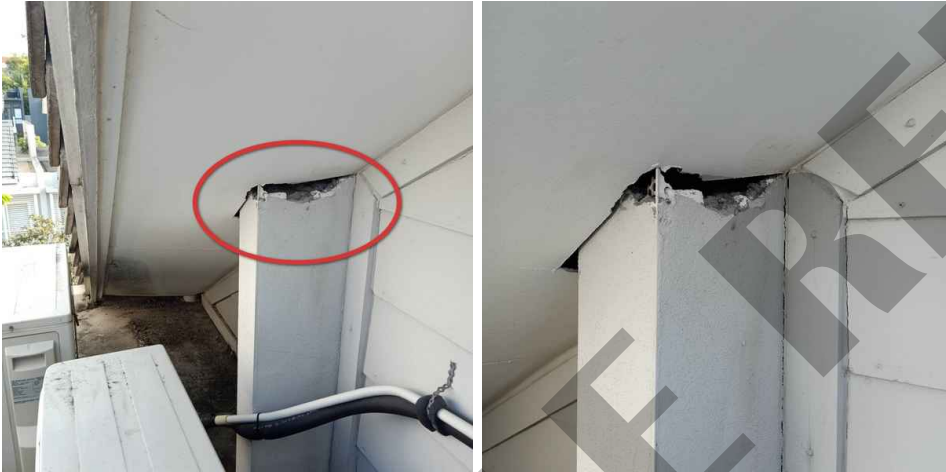
5.2.1 Walls

WALL - DAMAGES

Visible wall damages found to be on the top of the wall column. Recommend a qualified contractor to evaluate and remedy.

- Visible gaps
- Chipped

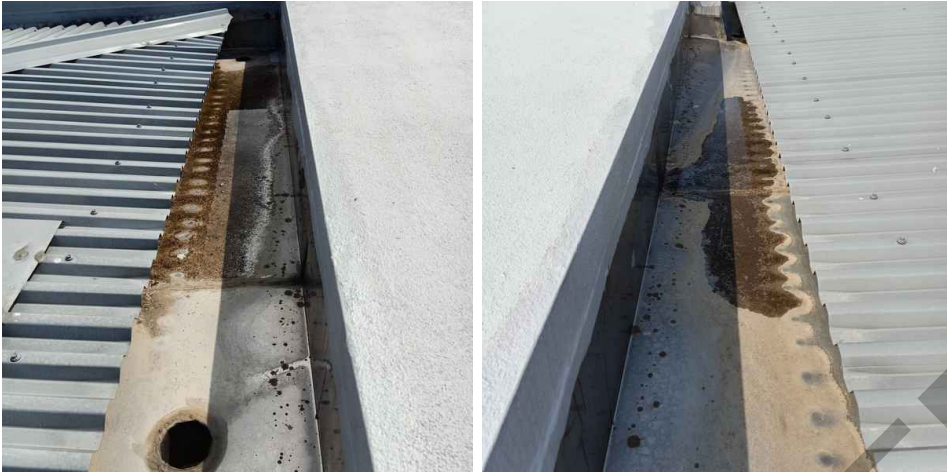
5.6.1 Fixtures

**ROOF GUTTER - ALIGNMENT AND EVENNESS**

Alignment issue found to be on the rain gutter surface that leads to poor water discharges. Recommend a qualified contractor to re-align the gutter.

- Misaligned rain gutter
- Water ponding

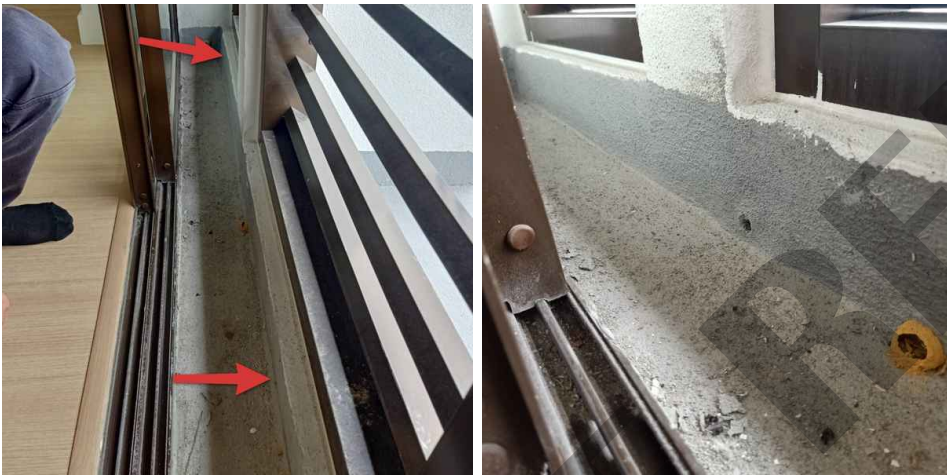
6.1.1 Floor

IMPROPER INSTALLATION

Weep hole for the water drainage found to be install higher from the flooring surface that can cause water ponding. Recommend a qualified contractor to evaluate and remedy.

- Improper installation of the weep hole

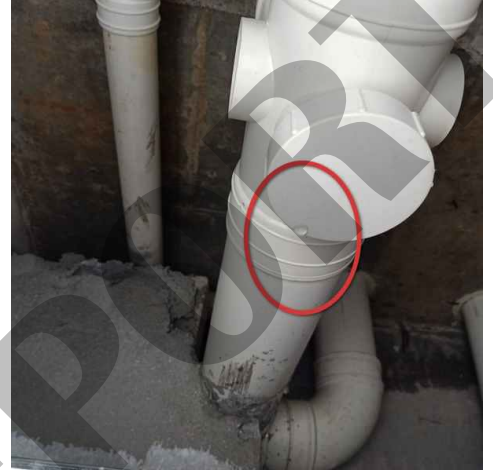
7.8.1 M&E Fittings

PIPING - WATER LEAKAGE

Visible sign of water leakage was observed at the drainage piping. Recommend a qualified contractor to evaluate and remedy.

- Sign of water leakage

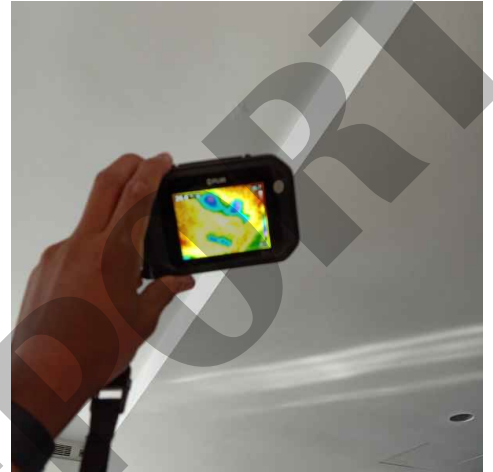
8.4.1 Ceiling

WATER LEAKAGE

Sign of water leakage was detected on the ceiling surface at the time of inspection. Thermal imaging camera was used and detected moisture presence. Recommend a qualified contractor to evaluate and identify the source of the water leakage and rectify the issue.

- Sign of water leakage
